Manhole Inspection Summary

Manhole # S11QQ1021MH

Insp Date: **4/26/07 2:24 PM**

Location Address: **PIMLICO ROAD**

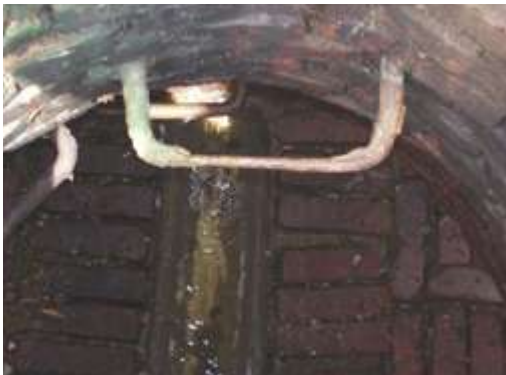
Defect 1

Count: **3** Missing: **0** ☒ **Corroded**

CORRODED RUNG

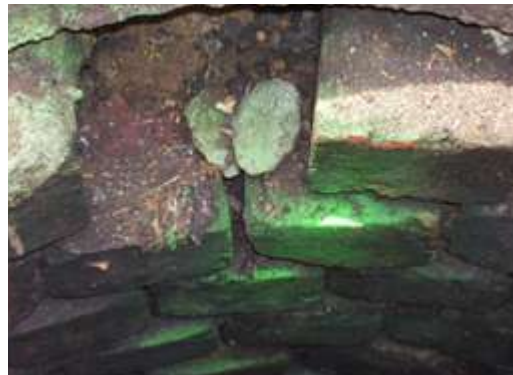
Defect 2

Condition: ☐ Sound ☐ Cracked ☐ Root Intrusion ☒ **Loose Brick** ☐ Deteriorated

LOOSE BRICKS IN CHIMNEY

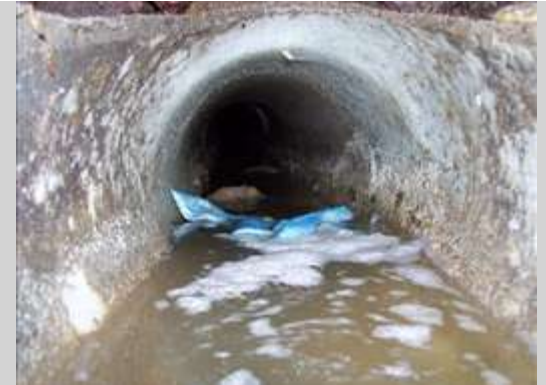
12 O'Clock Outflow

Condition: ☐ Sound ☐ Cracked ☐ Root Intrusion ☐ Deteriorated ☐ Leaks ☒ **Debris**

DEBRIS IN CHANNEL.

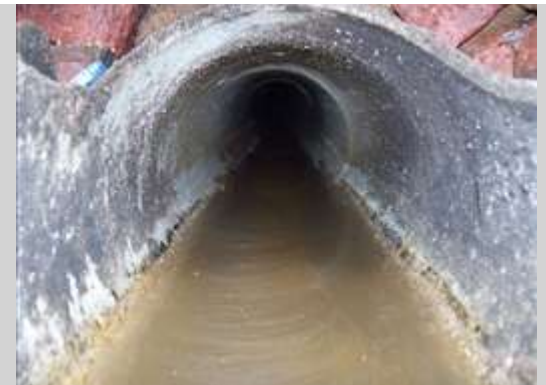
6 O'Clock Inflow

DEBRIS IN CHANNEL.

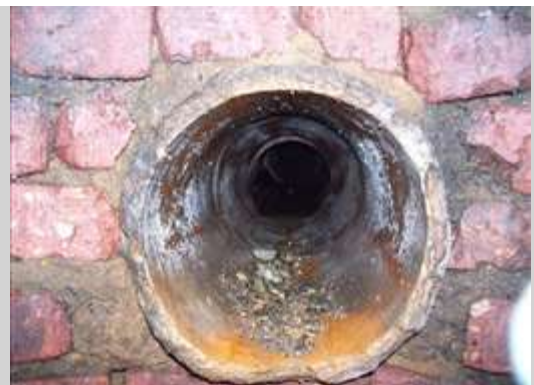
9 O'Clock Inflow

DEBRIS IN CHANNEL.

Infiltration: **None** Pipe Seal Cond: **Cracked**

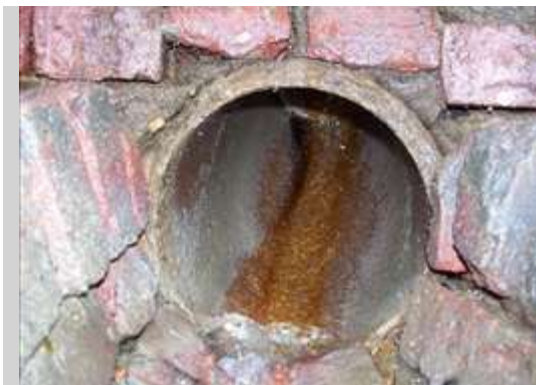
Drop In @ 9 O'Clock

DEBRIS IN CHANNEL.
